**An investigation into  
the southward  
migration of the  
Waimakariri River  
mouth**

**Report No. R11/121  
ISBN 978-1-927257-74-6**

Tony Boyle

May 2011

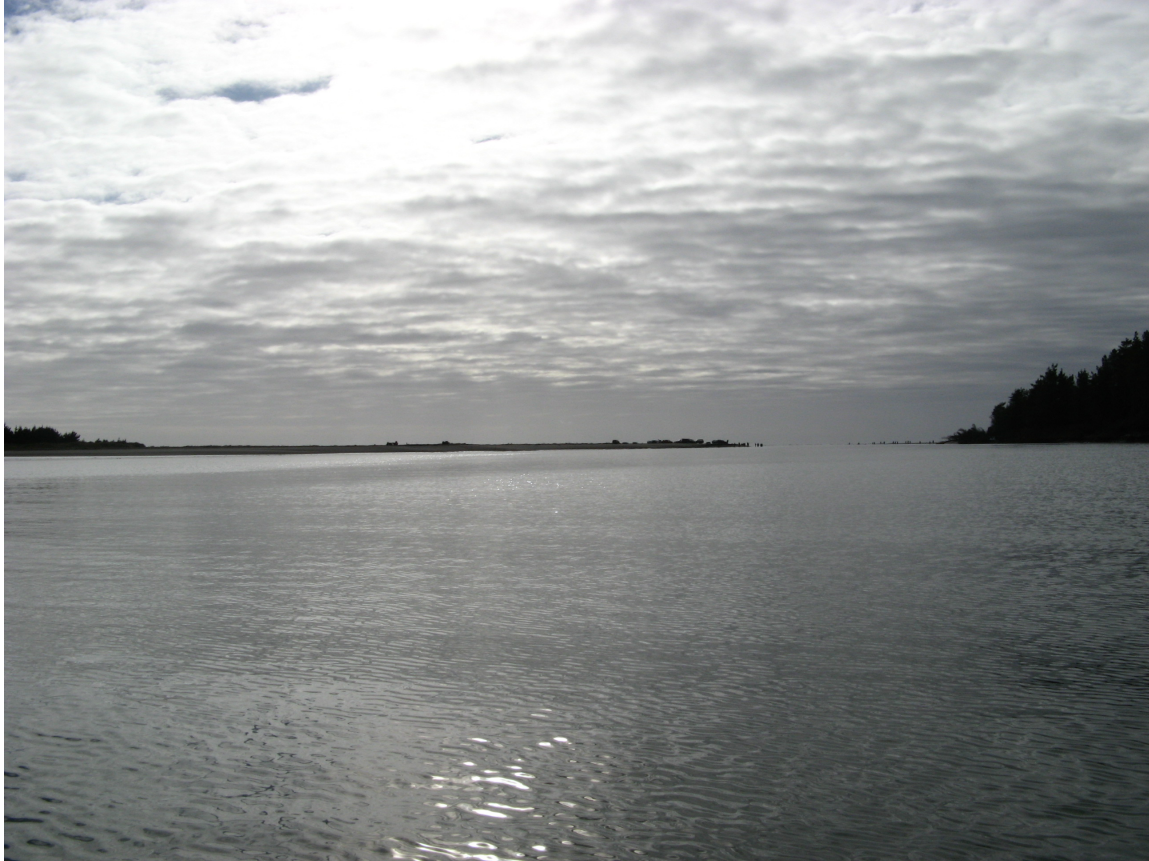
**Photo 1-1: The long northern spit with the mouth to the right**

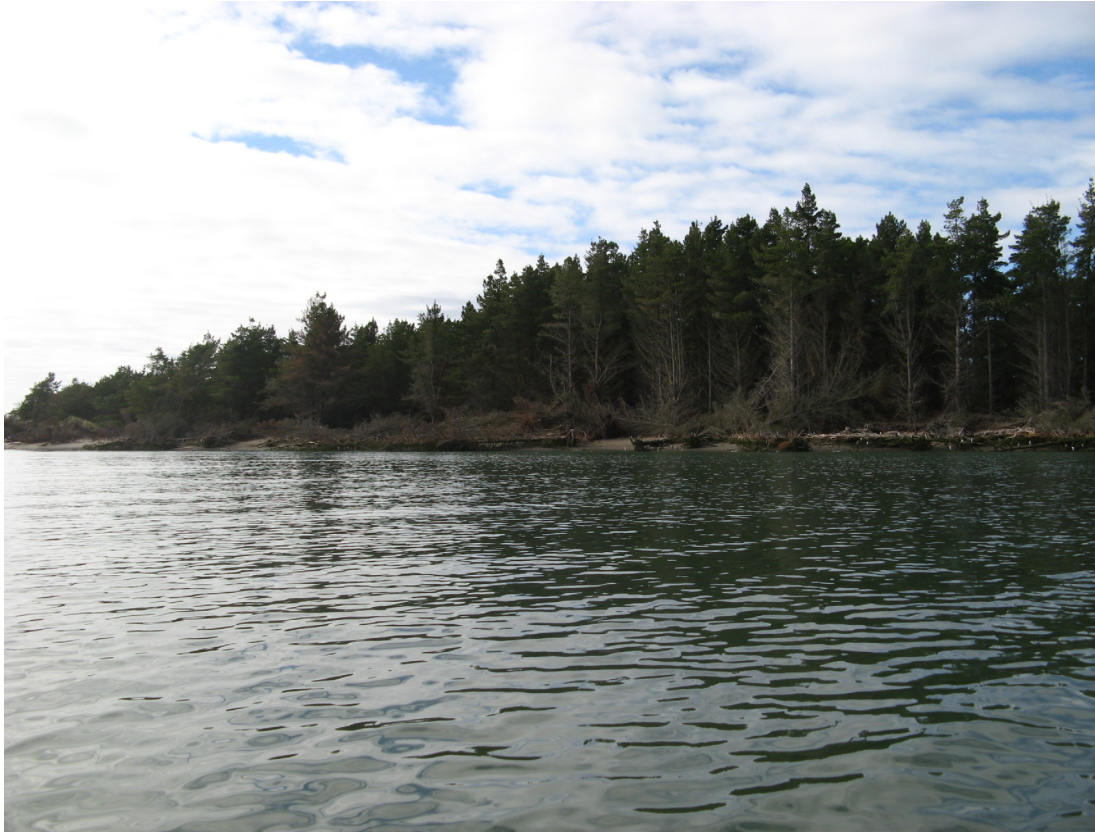
**Photo 1-2:** The eroding southern spit (currently 20 m/year)

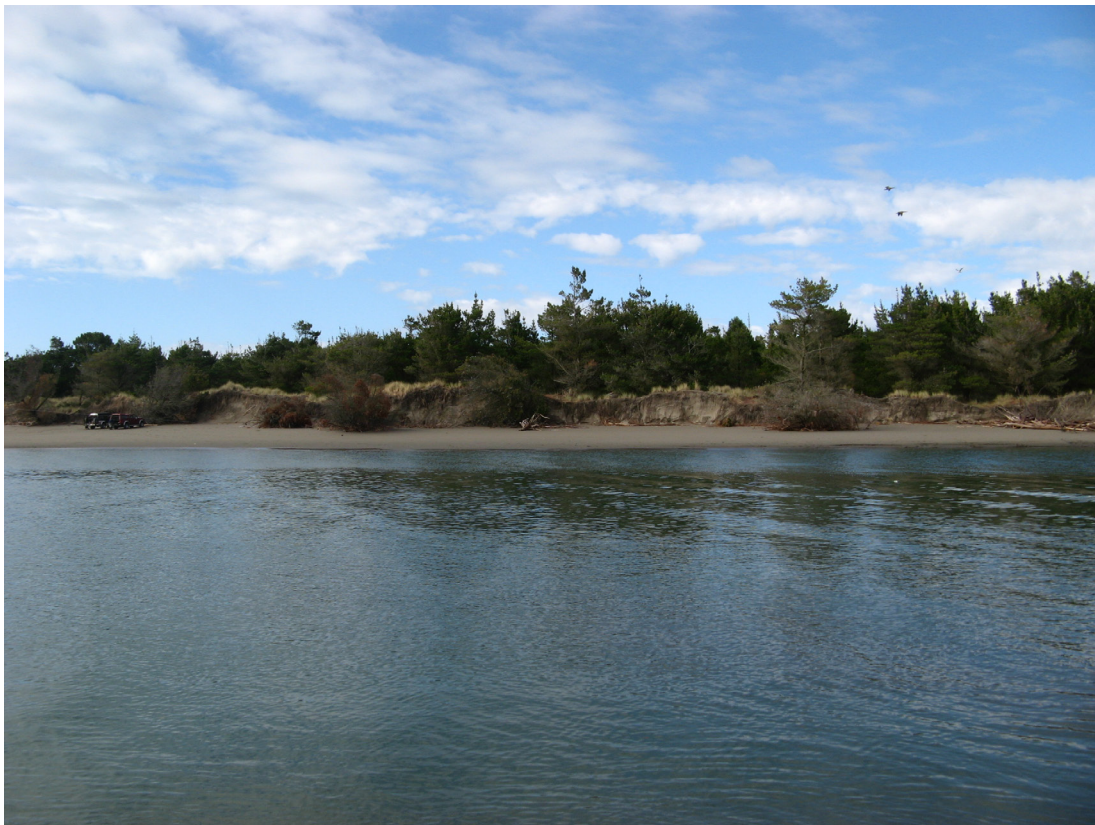
**Photo 1-3:** The rapidly eroding southern spit (2010-2011 – 20 m/year - up from 1 m/year previously)

There is no apparent pressing hydraulic necessity to halt the natural southern migration of the mouth. Even at the very maximum rate of movement (20m/year) it would take a very long time to move 3kms.
